# AERIAL ROOF INSPECTION REPORT

Capture date withheld · residential · roof surfaces and perimeter

| Scope | Residence — roof surfaces and perimeter |

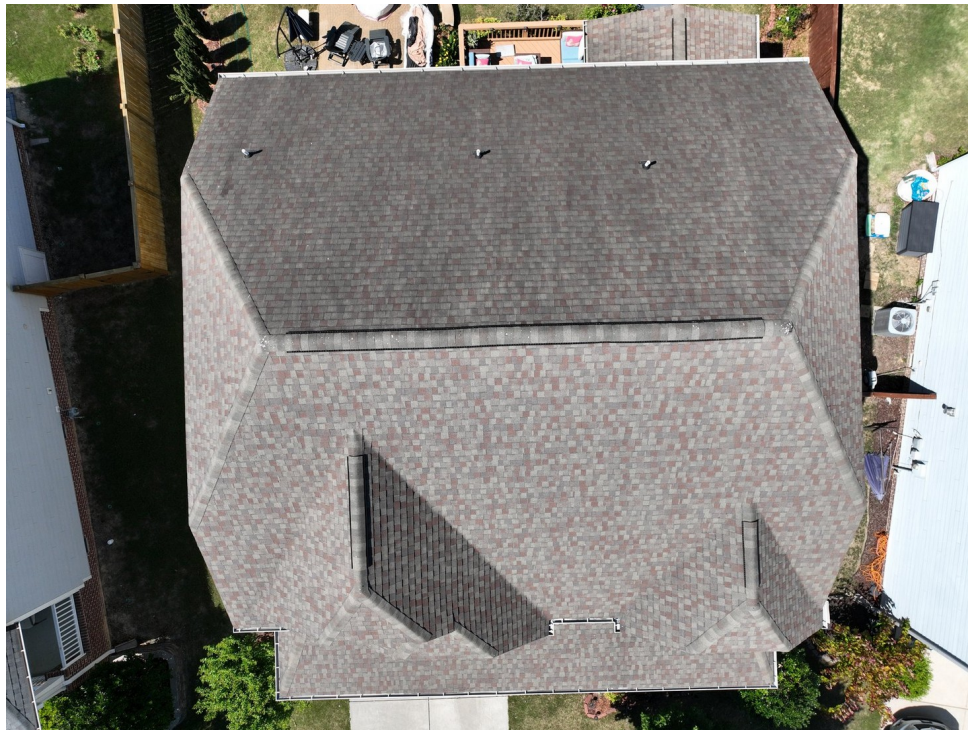
| LOCATION | ISSUE OBSERVED | SEVERITY |
|---|---|---|
| Rear slope — penetrations | Three plumbing vent stacks and the ridge vent appear seated and intact. Boot and collar condition is below the resolution of these frames and was not assessed. | LOW |

Fig. 1 — Full-roof overhead: hip-and-gable configuration, uniform shingle coverage, continuous ridge line with ridge vent, three plumbing vent stacks on the rear slope.

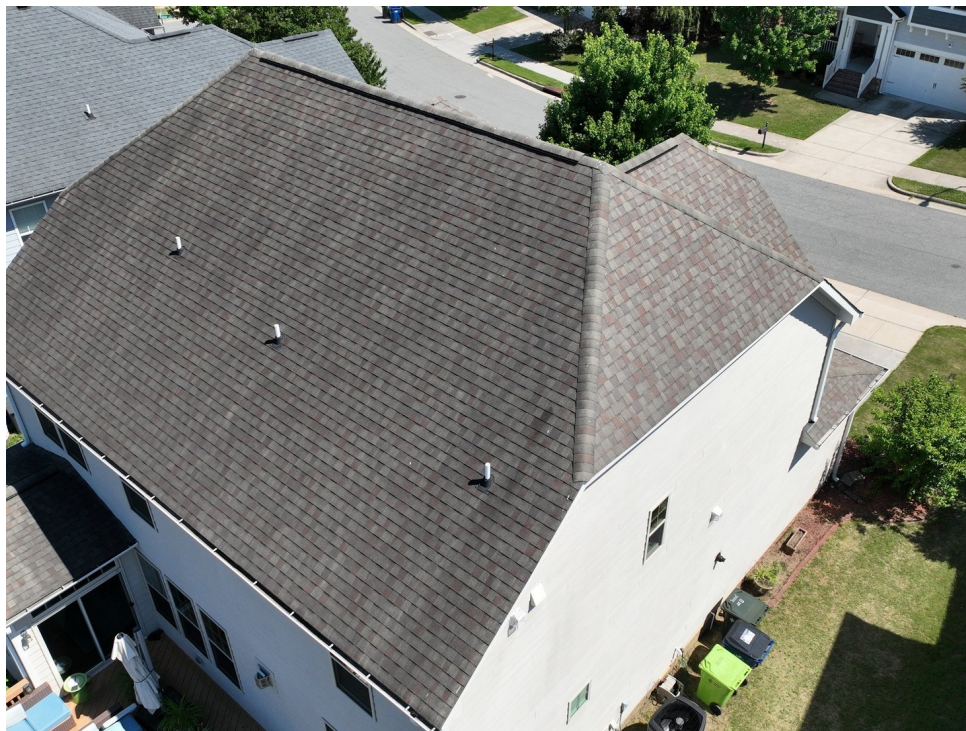
| LOCATION | ISSUE OBSERVED | SEVERITY |
|---|---|---|
| Main slopes — shingle field | Uniform architectural shingle coverage across all planes observed; courses aligned, no missing tabs, lifting, tarping or displaced ridge caps visible at capture resolution. | LOW |

Fig. 2 — Oblique, street side: main and wing slopes in context; ridge and hip lines straight, gutter line continuous, no displaced material visible on any slope in frame.

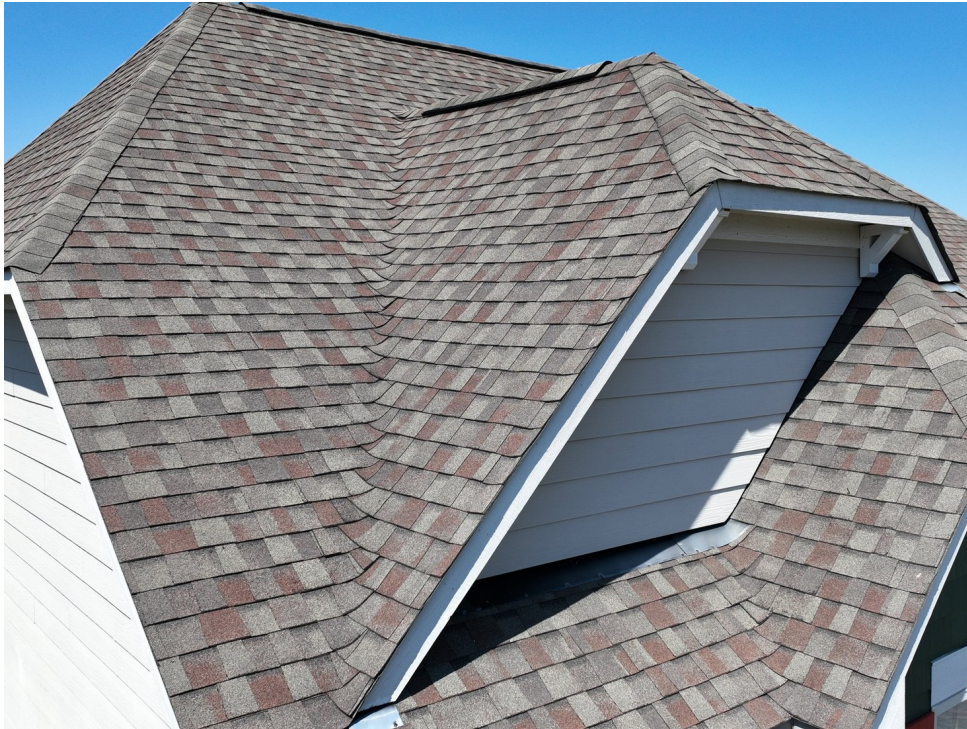
Fig. 3 — Oblique, dormer and upper slopes: valley and hip intersections seated, dormer flashing lines visible and continuous at capture resolution.

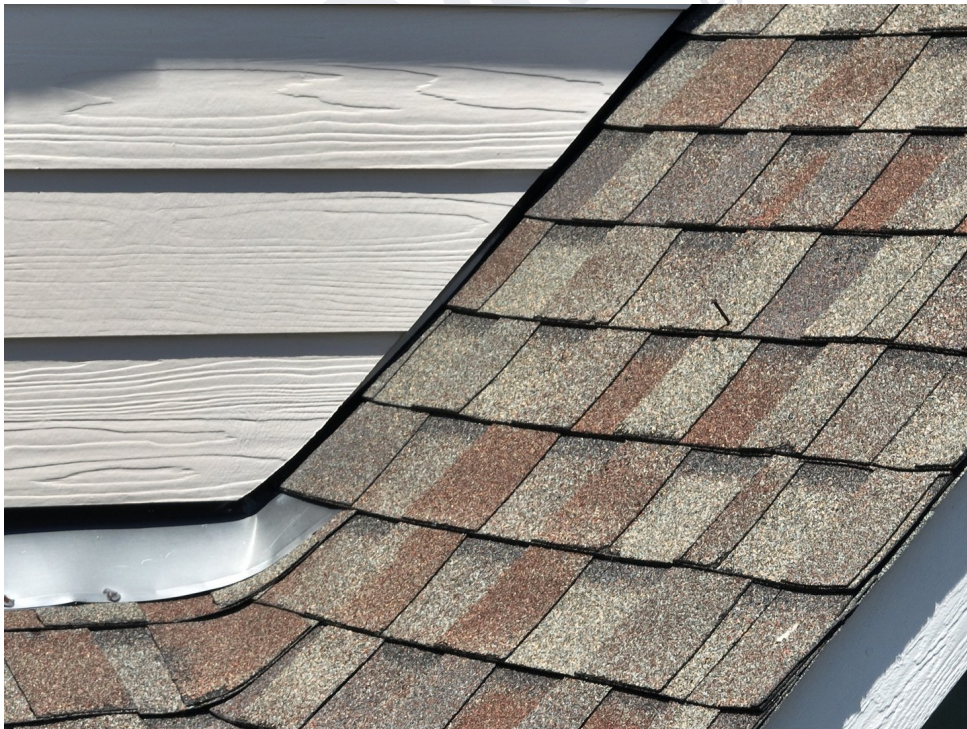
| LOCATION | ISSUE OBSERVED | SEVERITY |
|---|---|---|
| Perimeter — eave, drip edge and gutter | Drip edge, rake flashing and gutter line appear seated where visible from the air. Interior gutter condition and any debris load were not visible in these frames. | LOW |

Fig. 4 — Perimeter detail: shingle courses meeting the wall line; drip edge, rake flashing and gutter seated and lapped as visible.
